LAMPIRAN II
GAMBAR - GAMBAR

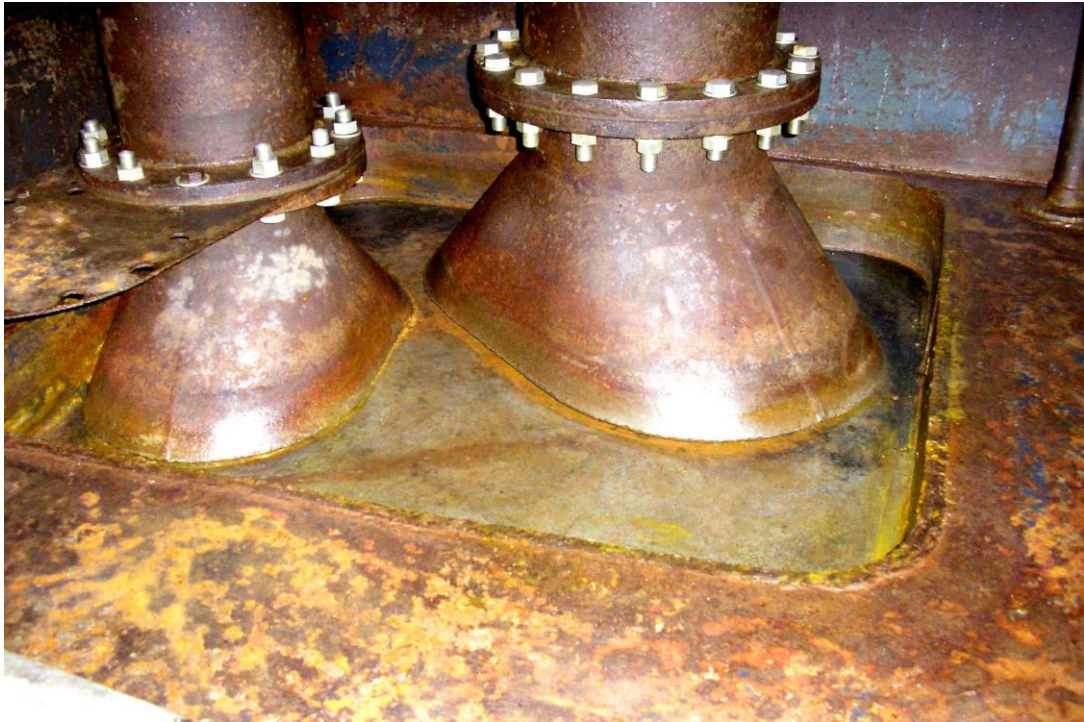
Gambar 7. Muatan yang masih tersisa di sekitar *bellmouth* akibat pelaksanaan tank cleaning yang kurang optimal.
