## Lampiran I

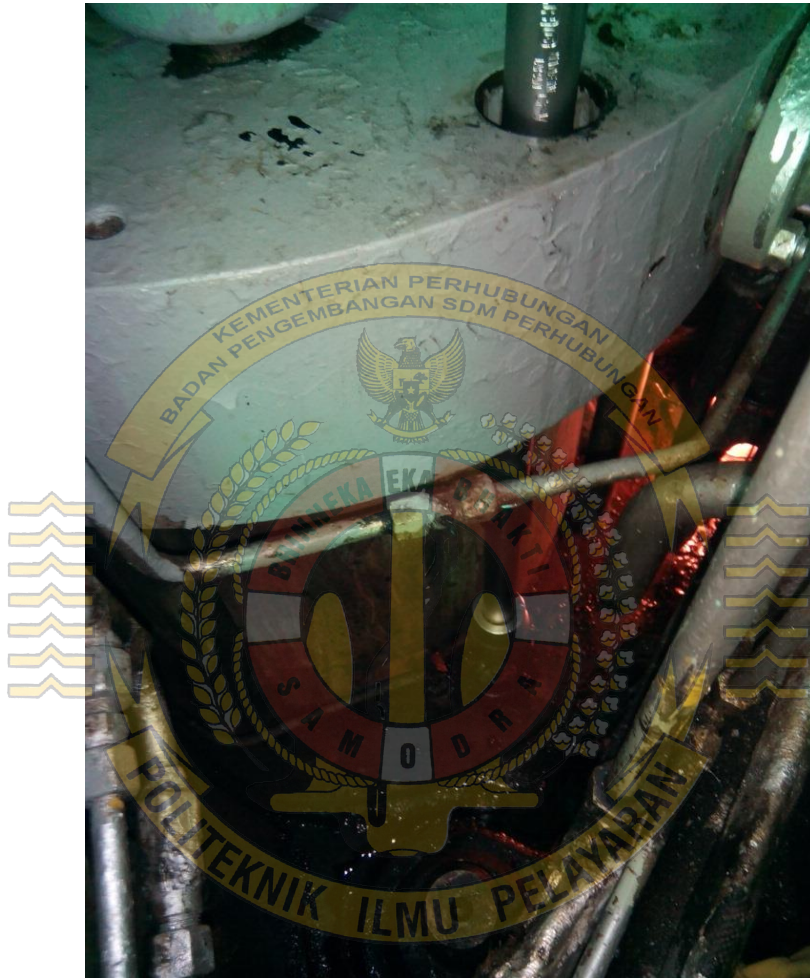
Gambar Proses pengeboran baut patah di MV. Lieke

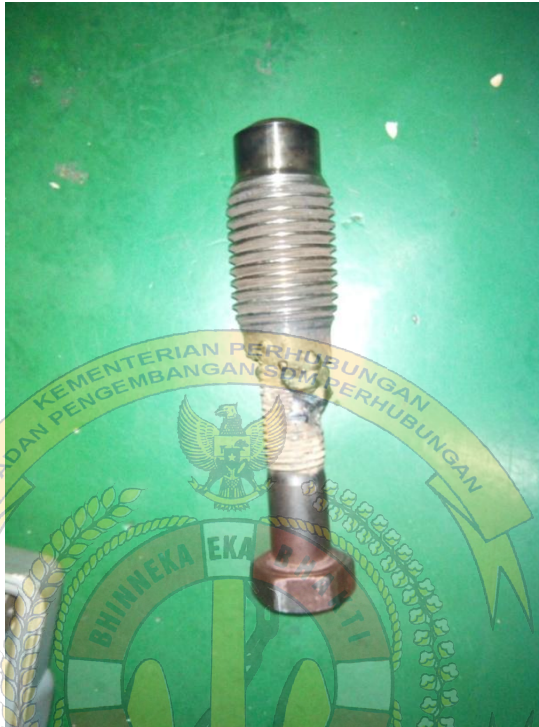
## Lampiran II

Gambar baut yang sudah di cabut di MV. Lieke
