LAMPIRAN GAMBAR

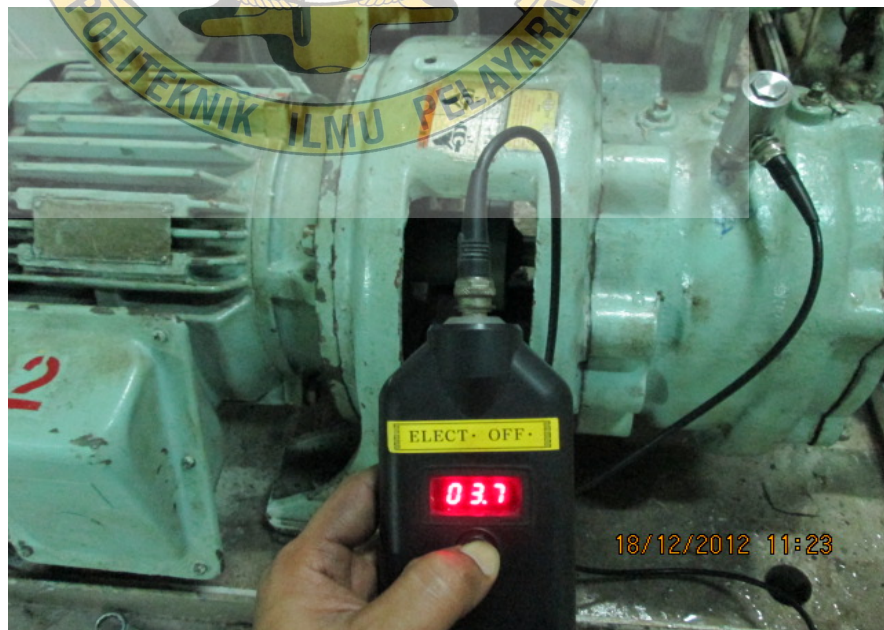
Lampiran 3

Gambar : vibration check pada boiler feed water pump

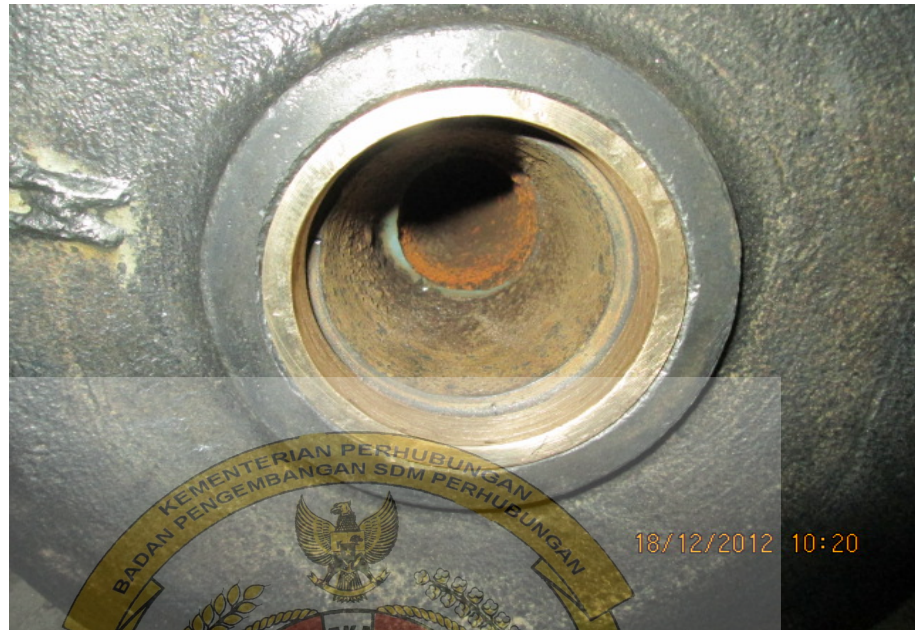
Lampiran 4

Gambar : rusaknya casing akibat kavitasi

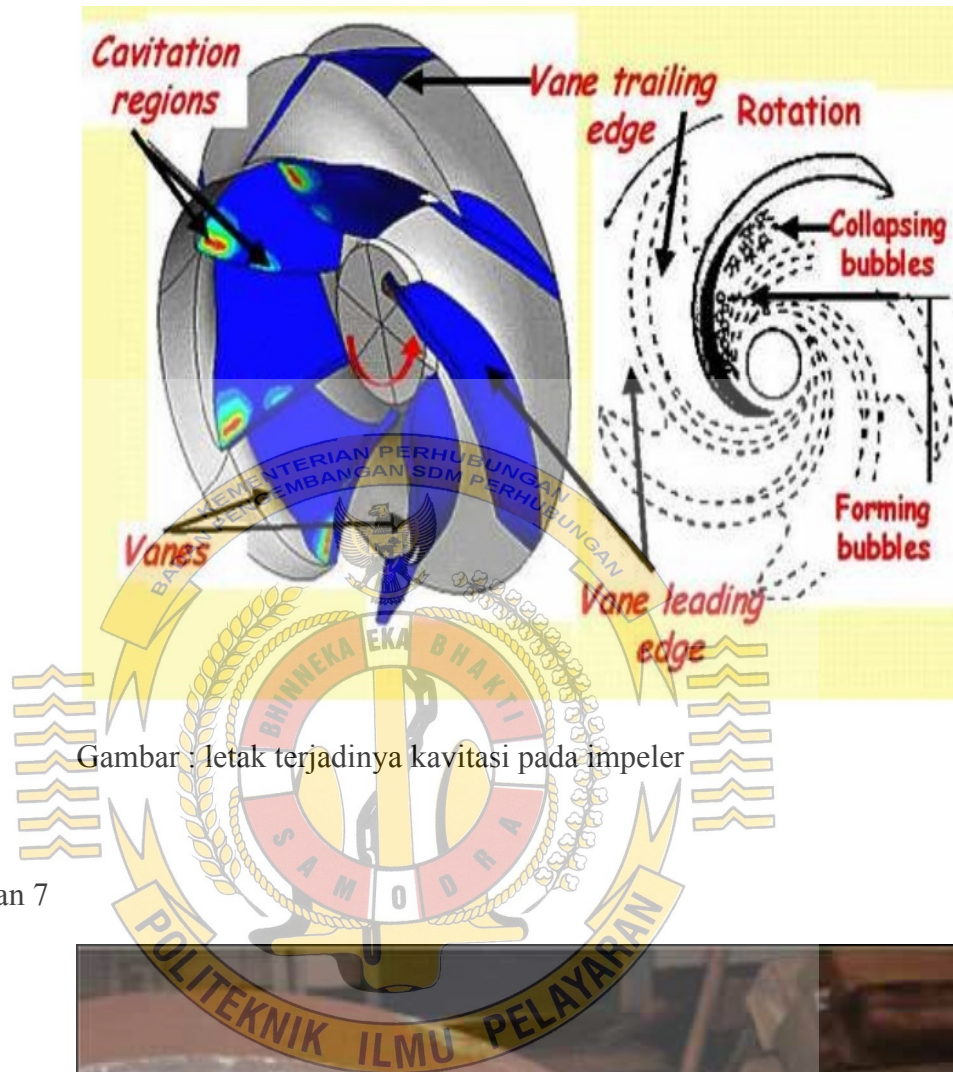
Lampiran 6

Gambar : letak terjadinya kavitasi pada impeler

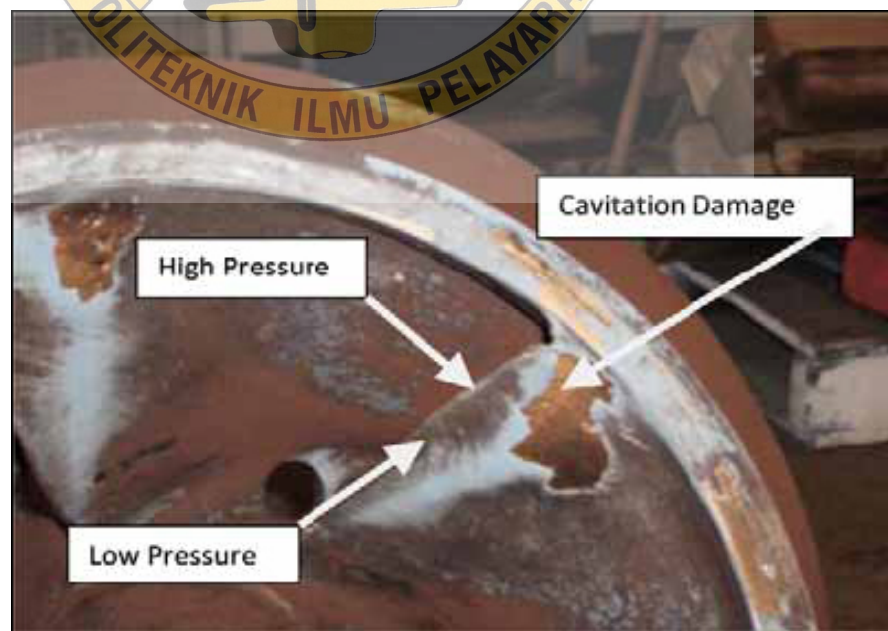
Lampiran 7

Gambar : kerusakan impeler akibat kavitasi

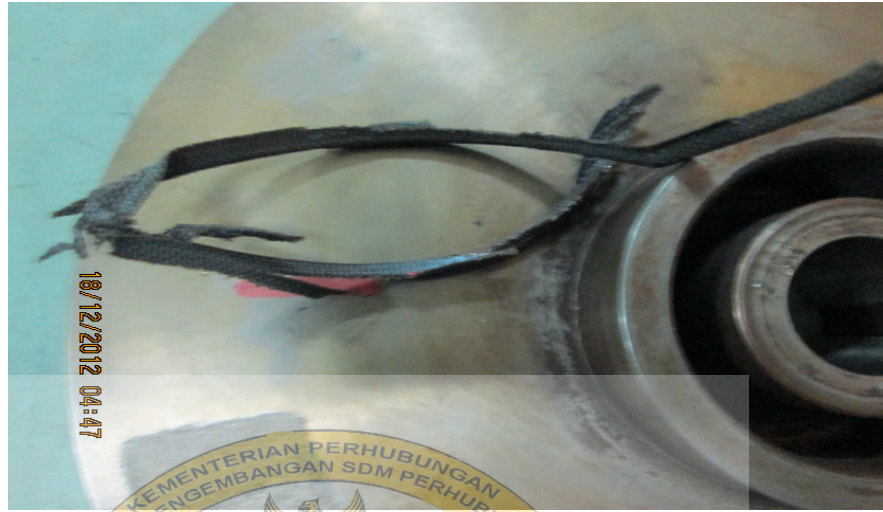
Lampiran 8

Gambar : kerusakan impeler boiler feed pump akibat fenomena kavitasi di MV. NYK LYRA
