BAB IV PENUTUP

Finger Injury during Mooring Activity

(Issued: 9th February 2013)

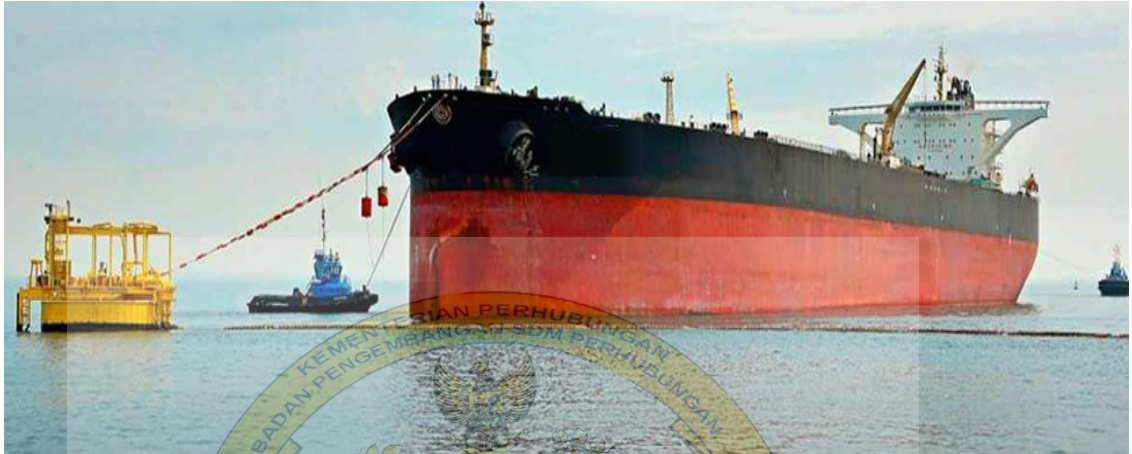
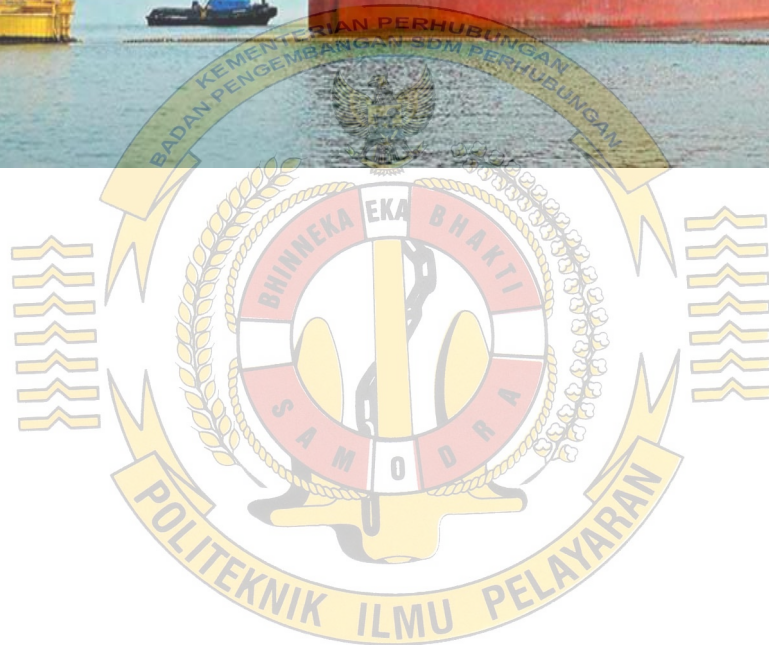
Lampiran 5. Contoh kegiatan *Assist Berthing* di SBM

A serious finger injury occurred recently on board during assist berthing on SBM, a crew member got his ring finger pinched between towing bitt and towing line, he was tried to tighten the towing line whilst it was already secured and the Tug has commenced towing operation.

1. Use the Correct Tools for the Task
 - Use High Impact Resistance Gloves for all mooring activity
2. Prepare for the Unexpected
 - Keep clear from "Snap Back Zone" during towing operation, and more vigilant to pinch point
