PT SALAM PACIFIC INDONESIA LINES MY ORIENTAL RUBY / POGB

SHIP PARTICULARS

Tabel Evaporation data sheet of EGE Assamble of EGE

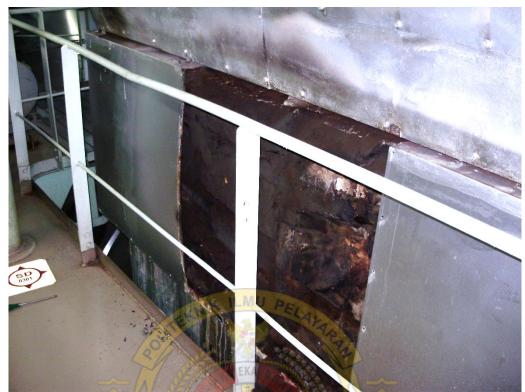
Kerusakan pada insulator panas dari *EGE*

- Cadet : Siap chief. Seperti kejadian pada tanggal 24 Maret 2017, pada *high* pressure boiler circulating pump terjadi kebocoran benar begitu, Chief?
- KKM : Benar sekali, Cadet! Dan juga terjadi kerusakan pada insulator pemanas dan *cover EGE*.

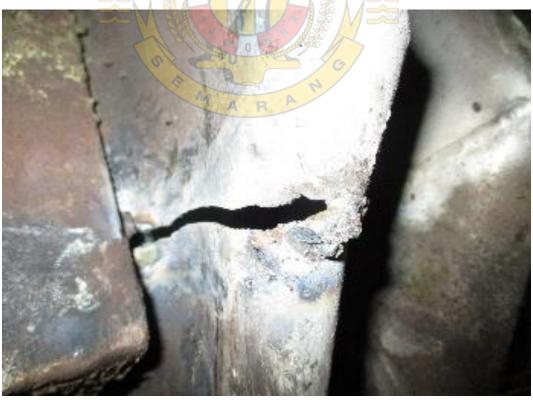
Kerusakan pada *cover* dari *EGE*

EGE terhadap produksi uap, Bass?
- Masinis 3: Pada Kerusakan pada cover EGE dilakukan pemeriksaan pada saat drydock pada bagian EGE termasuk superheater side dan pemberian tanda kerusakan pada superheater side. Diketahui kerusakan pada pipa juga saat drydock dan dilaksanakan pengelasan pada pipa yang bocor dan penggantian cover yang telah rusak pada superheater side. Dilakukan pengawasan pada pengelasan ketika pengecekan harian saat kapal telah meninggalkan drydock. Ketika menemukan kebocoran pipa air panas pada sistem EGE di MV. Oriental Ruby maka untuk menemukan letak kebocoran pada sistem EGE harus mengurutkan pipe line dari A/E turbin generator sampai EGE. Setelah menemukan penyebabnya dilakukan tindakan awal dengan mematikan power di panel room dan memberi tanda "lock out" serta menutup katup masukan dan keluaran pada high pressure boiler circulating pump untuk memhentikan sumber air panas dari feed water tank. Setelah air panas dapat terkendali pipa yang bocor diberi tanda. Sebelum

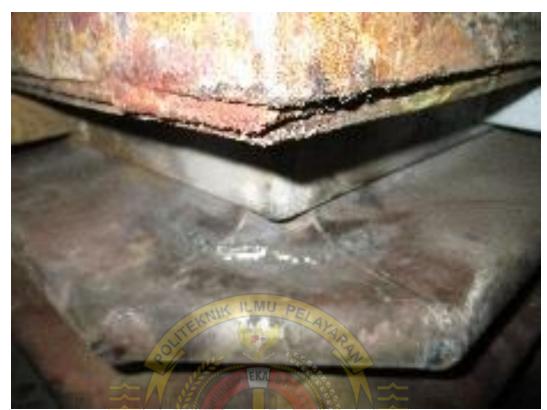
Perbaikan pada *cover* dari *EGE*

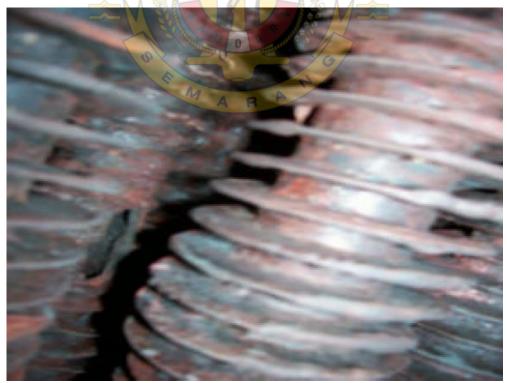
Kerusakan pada pipa EGE

- Cadet : Apa saja upaya yang dapat dilakukan untuk meningkatkan kinerja EGE terhadap produksi uap, Chief?
- KKM : Pada *high pressure boiler circulating pump* kita lakukan *overhaul* untuk mengetahui bagian mana yang rusak. Kalau terjadi kebocoran pada pompa pasti kerusakan pada *mechanical seal*. Untuk kebocoran pada pipa EGE kita laporkan ke perusahaan agar diperbaiki saat *drydock*.

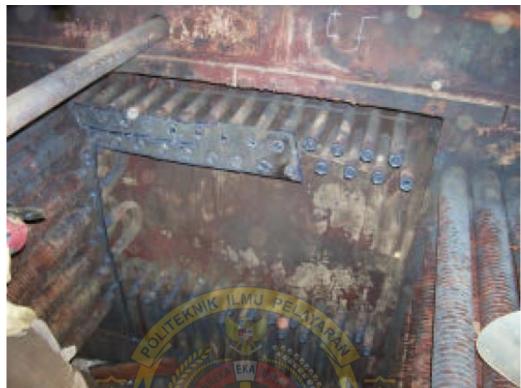
Pemotong<mark>an</mark> pada pipa *EGE*

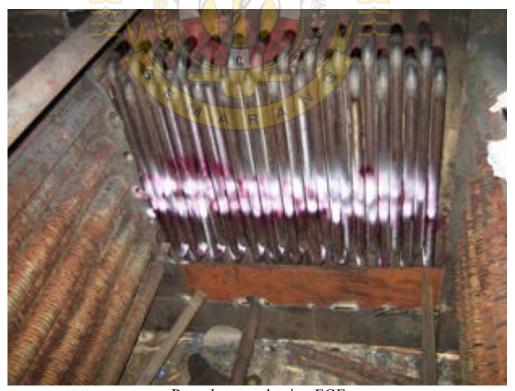
Pengelasan pada pipa EGE

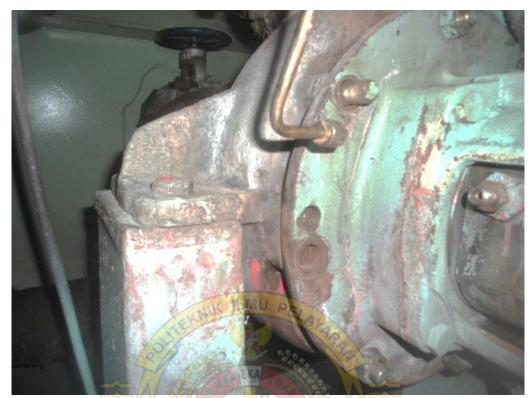
Kebocoran pada pompa

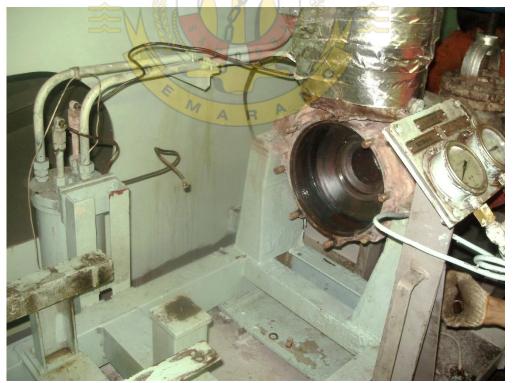
Pelepasan Pompa

melaksanakan overhaul dilakukan pemeriksaan pada check alignment coupling, kekurangan/kesalahan grease, visual check lubricating oil dan lubricating oil level. Setelah dipastikan tidak ada masalah dilakukan pembongkaran pada pompa. Pemeriksaan pembongkaran dilakukan dengan memperhatikan body gasket, visual check impeller, casing wear ring clearence, check impeller, volutes, balance hole, gauge dan indikator yang lain. Setelah itu dilakukan pemeriksaan diluar pompa, misalnya flush lines dan quench lines untuk mengetahui apakah terjadi corrosion atau tersumbat pada lines. Hasil dari pemeriksaan ditemukan masalah pada mechanical seal rusak. Perbaikan high pressure boiler circulating pump dilakukan di bengkel agar tidak mengganggu karena suara bising yang ditimbulkan kerja peralatan yang menunjang perbaikan. melakukan perawatan dan perbaikan di MV.Oriental Ruby terdapat mechanical seal yang rusak yang diakibatkan overheat. Pergantian mechanical seal dilakukan sesuai Instruction Manual Book Exhaust Gas Economizer yang menggunakan mechanical seal produk asli dari Shin Shin Machinery. Ukuran dan ketahanan mechanical seal diperhatikan untuk mencegah kebocoran. Selain mechanical seal yang rusak juga terdapat various gasket yang rusak. Setelah selesai diperbaiki dilakukan perakitan kembali dan memasang pompa pada tempatnya. Setelah terpasang dilakukan pengujian untuk memastikan bahwa dapat bekerja dengan normal. setelah melakukan overhaul pada high preassure boiler circulating pump dilakukan kegiatan pengawasan pada bagian yang telah diperbaiki untuk memastikan tidak terjadi kebocoran lagi. Pengawasan juga menjadi upaya untuk respon cepat untuk mengatasi kebocoran pada pipa apabila terjadi kerusakan yang baru.

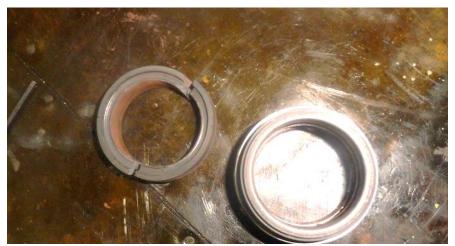
Kerusakan pada mechanical seal

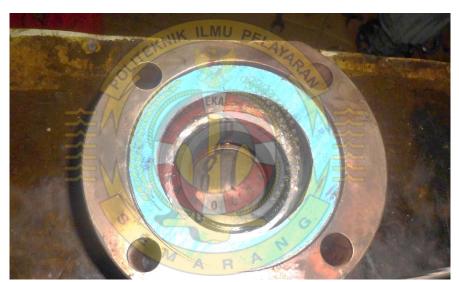
Perngantian pada mechanical seal
